## Soil Physical Characteristics and Erosion Potential for Urban Agricultural Land Conservation in Samarinda Ilir

*Urban agricultural land in Samarinda Ilir faces limited land availability and increasing erosion risk on sloping areas. This study aimed to analyze soil physical properties and erosion potential as a basis for developing soil and water conservation strategies to support urban agriculture. A descriptive qualitative approach was employed through field observations in Pelita Village and the Kuburan Cina Street slope, Samarinda Ilir District. Data were collected by observing soil physical properties, vegetation cover, topography, land management, and field documentation. The results showed that the soil in Pelita Village has the potential for urban farming but requires the addition of organic matter and reduced soil compaction. In contrast, the Kuburan Cina slope exhibits a high erosion risk due to steep slopes, sparse vegetation, and the absence of conservation measures. Therefore, soil conservation efforts should include soil quality improvement, revegetation, contour drainage, infiltration pits, mulching, and regular slope monitoring.*

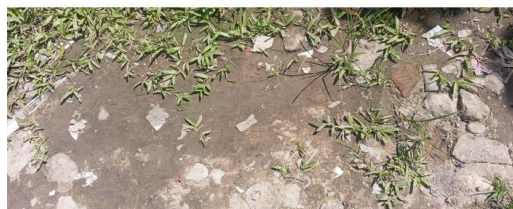
**A. Soil surface**

The observed soil in Pelita Subdistrict had a brown color with the Munsell code 7.5 YR 4/4. Brown color in tropical soils is generally associated with mineral weathering and the presence of iron oxides under relatively well-aerated conditions. In the context of home-garden agriculture, this color suggests that the observed sample represents mineral topsoil; however, color alone cannot determine fertility status. Further analysis of pH, organic matter, cation exchange capacity, nitrogen, phosphorus, and potassium is still required to evaluate crop suitability more comprehensively.

The soil texture was classified as moderately coarse. This characteristic indicates that sand or relatively coarse particles were more dominant than clay fractions. Moderately coarse soil generally drains more quickly but retains less water and nutrients than medium-textured soil. Syahputera et al. (2024) showed that physical and chemical parameters, including texture, moisture content, bulk density, and nutrient-related properties, jointly shape soil quality in plantation land. For home-garden agriculture, moderately coarse texture should therefore be balanced by organic matter amendment, mulch application, and ground cover so that soil moisture becomes more stable.

The soil structure was identified as very coarse angular blocky, with an aggregate size of approximately 20 mm. Angular blocky structure indicates the presence of aggregation, but very coarse aggregates are not ideal for fine-root development. This condition may result from wetting-drying cycles, root activity, soil organisms, and human disturbance. In residential land, soil structure is often altered by foot traffic, filling, excavation, or construction activity. The findings of Bintoro et al. (2017), which show differences in soil physical properties among land-use types, support the interpretation that spatial-use change can alter surface-soil characteristics.

Figure 1. Documentation of soil observation in Pelita Subdistrict  
(Source: Primary documentation, 2026)

For the Pelita site, recommended practices include applying mature compost, organic mulch, rice husk, and leaf litter to improve aggregation and moisture retention. Raised planting beds can be established with fixed walking paths to prevent repeated compaction in root zones. Low ground-cover plants should be maintained in areas not used for planting to reduce direct raindrop impact. These strategies support home-garden agriculture because moderately coarse texture and very coarse angular blocky structure require organic inputs to become a more stable medium for vegetables, medicinal plants, and small fruit crops.

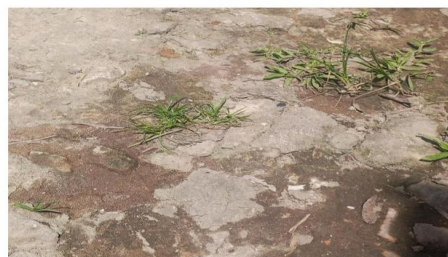
**B. Limited open land**

The two research sites displayed clearly different site characteristics. Pelita Subdistrict is a dense residential environment where open soil is extremely limited. The observable soil area consisted of a small yard or vacant spot between buildings and hardened surfaces. This condition indicates that the soil may have been affected by anthropogenic disturbance such as trampling, filling, excavation, construction-material mixing, and reduced infiltration space. Nevertheless, the remaining open soil is still important because it can function as a medium for home-garden agriculture if its physical quality is improved.

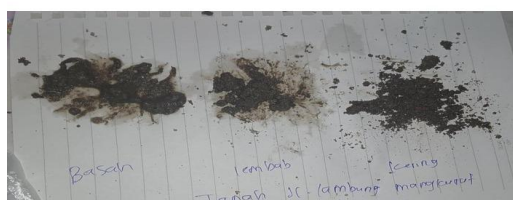
**C. Wet-moist-dry samples**

Soil consistency was non-plastic but sticky under wet conditions, very friable under moist conditions, and soft under dry conditions. This combination is consistent with moderately coarse texture and low plasticity. Very friable moist soil can support root penetration, but soft dry consistency indicates weak cohesion. If the soil is left exposed, aggregates may be broken by raindrop impact and fine particles may be displaced as

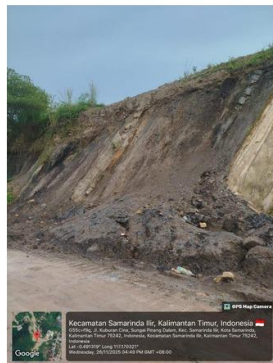
#### A. Exposed cut slope

The Kuburan Cina slope showed stronger erosion-triggering factors than the Pelita site. The topography consists of an artificial cut slope with exposed soil and rock surfaces. Under high rainfall conditions, exposed slopes receive direct raindrop impact energy. Water then moves downslope as surface runoff, detaches soil particles, and transports material to the slope foot or road surface. This is consistent with Farikha et al. (2023), who found that land use and slope condition influence erosion hazard indices.

Visually, the upper slope layer was dominated by yellowish-brown soil, interpreted in field observation as being close to the characteristics of Red-Yellow Podzolic soil or Ultisol. In the middle to lower part of the slope, a dark grayish sedimentary layer was observed and reported to become slippery when wet. This characteristic is important because material behavior under wet conditions can reduce slope stability. Septiaji et al. (2024) explain that Ultisols may have slow permeability and low aggregate stability, making them susceptible to erosion. Surface-water control and improved soil cover are therefore priorities at this site.

The main problem at the Kuburan Cina site is the interaction of steep cut-slope morphology, high rainfall, limited vegetation cover, easily detached material, and inadequate conservation infrastructure. No terracing, directed drainage, infiltration pits, or retaining structures were identified on the most exposed slope sections. These conditions may increase sheet erosion, rill erosion, and shallow mass movement. Slope documentation is shown in Figure 2.

Figure 2. Slope condition and eroded materials along Kuburan Cina Street  
(Source: Primary documentation, 2026)

For the Kuburan Cina site, vegetative conservation should be the first priority. Revegetation can be implemented using slope-strengthening grasses, ground-cover plants, local shrubs, and deep-rooted plants in safe zones. Plant selection should consider slope loading, root depth, maintenance needs, and tree-fall risk. Nurida et al. (2018) showed that agroforestry models have potential for rehabilitating degraded land in East Kalimantan, while Akbar (2021) recommended agroforestry conservation, cover crops, mulch, terraces, and reforestation to reduce erosion in risk-prone land.

Simple mechanical conservation is also needed on the Kuburan Cina slope. Drainage channels should be aligned along contour directions and equipped with energy dissipaters so that runoff does not directly attack the slope face. Where feasible, infiltration pits, contour bunds, small terraces, and routine removal of sediment from the slope foot can reduce effective slope length and slow runoff. Anggraini et al. (2019), Sarminah et al. (2023), and Mirza et al. (2023) underline the importance of erosion hazard assessment and land-use guidance for determining appropriate conservation measures. A summary of recommendations is presented in Table 3.
